# SSR1 Fabrication status at IUAC

P.N. Prakash, J. Sacharias, K.K. Mistri, A. Rai,  
D. Kanjilal and A. Roy

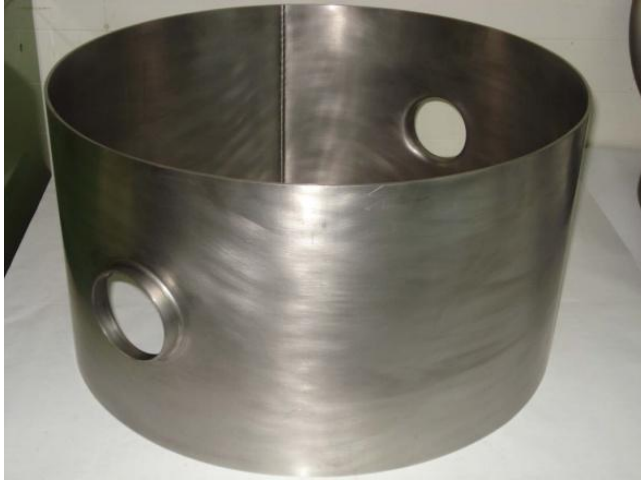
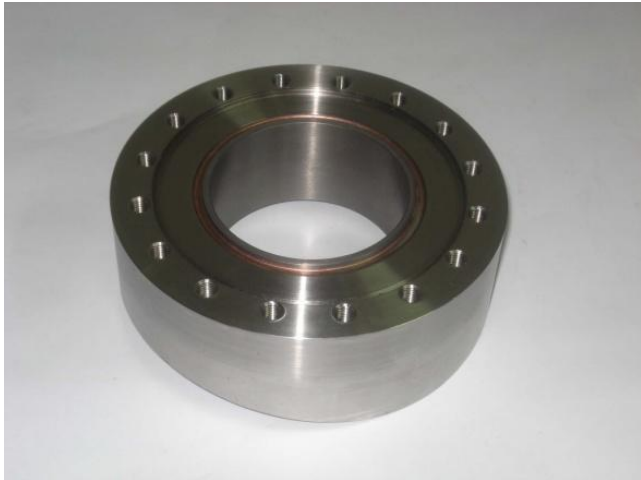
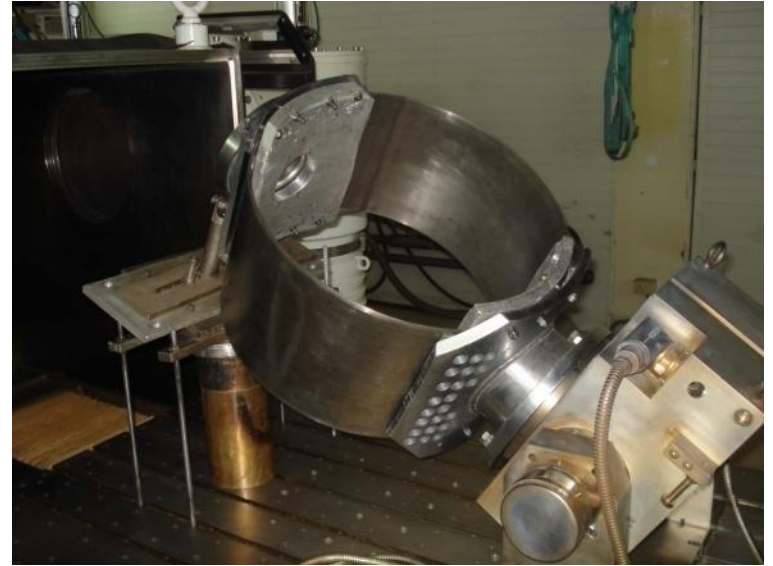
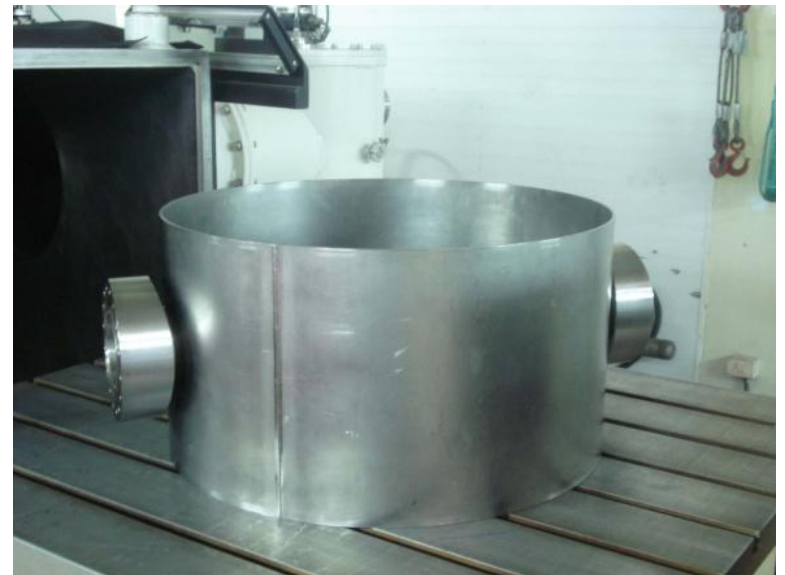
- ❖ EB welding of coupler ports to the two SSR shells completed.
  - A non trivial weld due to inaccessibility of the weld joint from the outside because of design changes in the coupler port.
  - Special fixture had to be made to hold the shell in a tilted position to do the welding from inside.
  - Space constraints from the size of the EB machine vacuum chamber.

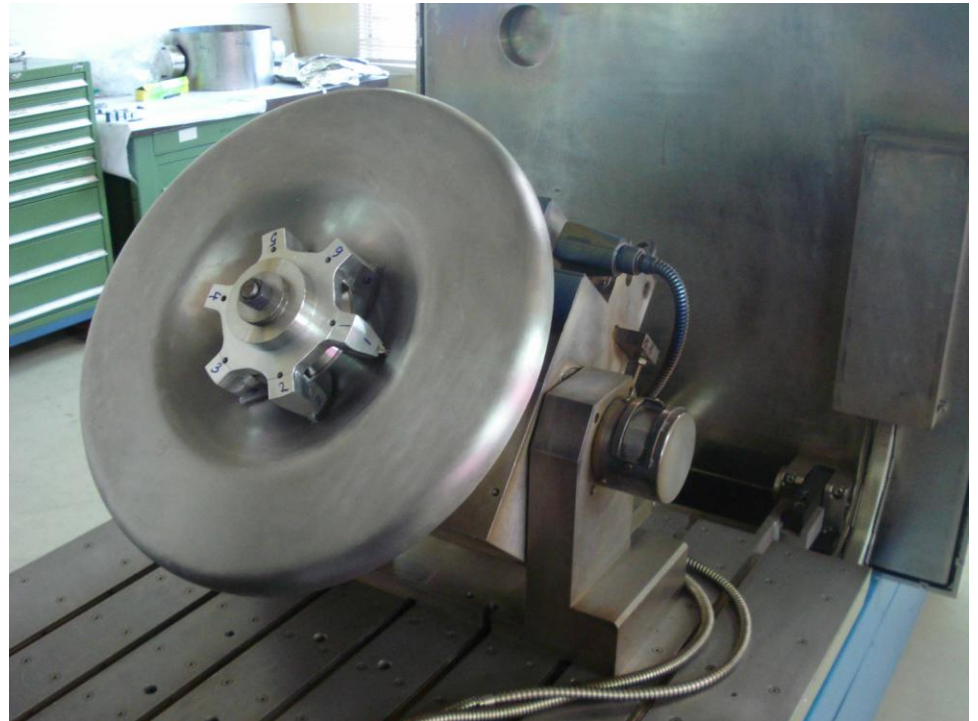
## ❖ Daisy Rib welding.

- All twenty four daisy ribs have been tack welded to the four End Walls.

- A total of  $4 \times 6$  welds per End Wall  $\times$  4 End Walls =  
96 total tack welds  
done in eight settings

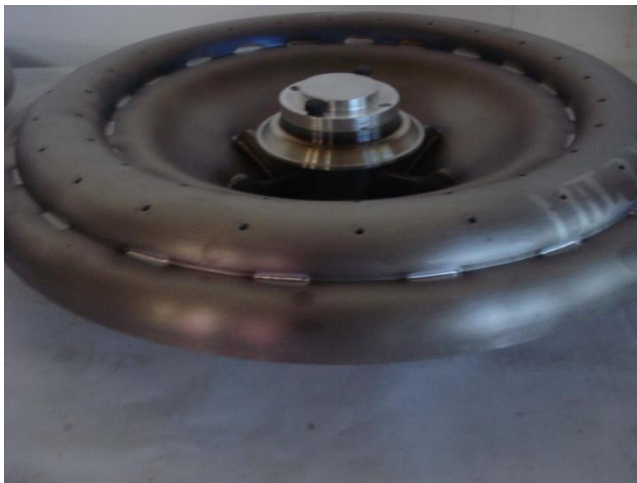
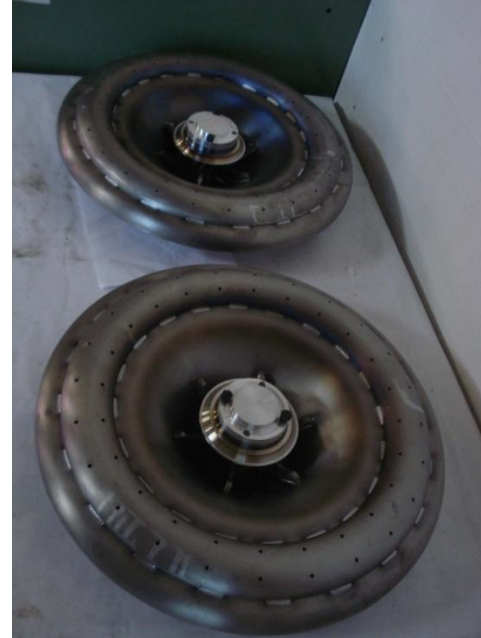
## ❖ Donut Rib welding.

- Two Donut Ribs have been welded to two End walls. A third one is presently in the process of being welded.

A total of 40 welds per End Wall  $\times$  4 End Walls =  
160 total welds have to be done.  
Each End Wall needs 4 settings.

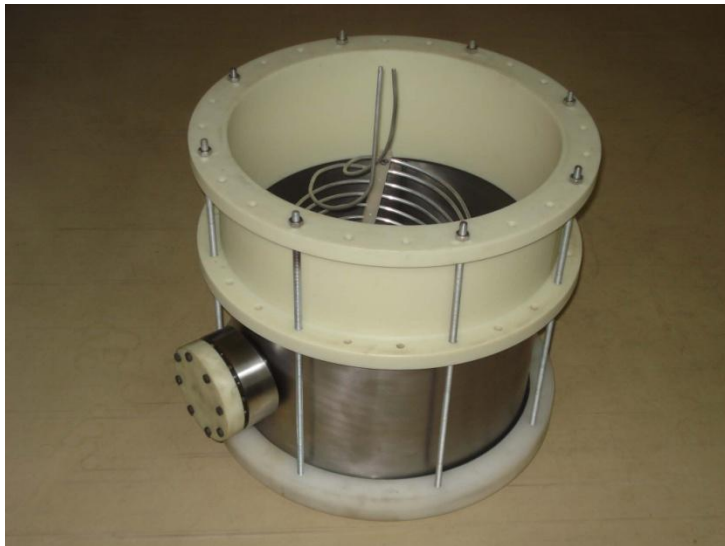
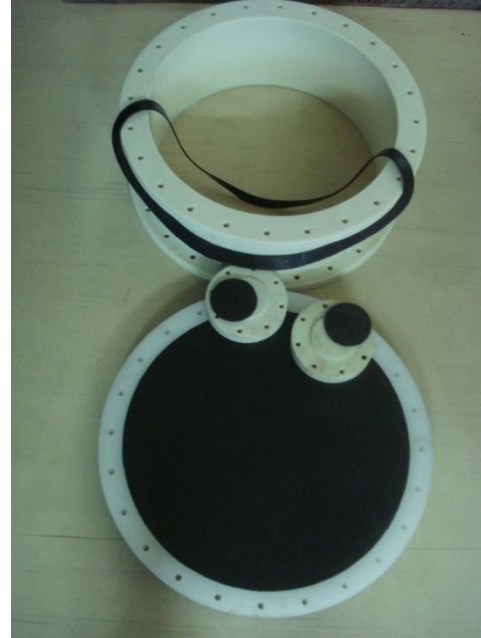
## ❖ Electropolishing (EP) of the SSR parts.

- EP fixtures and all associated paraphernalia (aluminum cathode, secondary containers etc.) are ready for the EP of the two Shells and the four End Walls
- Sufficient quantity of acids have already been procured for the EP of all the resonator parts
